# Detection and Location of Leaks in Geomembrane Liners Using an Electrical Method: Case Histories

Daren L. Laine

Southwest Research Institute

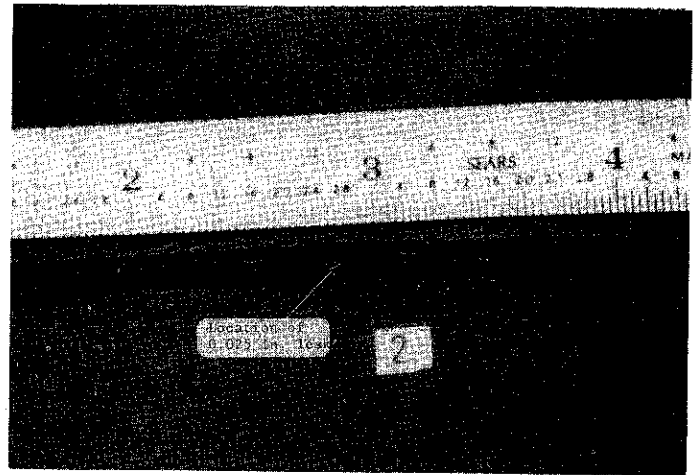
percent of the leaks were in seams, and the remaining 13% were in the parent material. Figures 8 and 9 show examples of seam leaks detected with the Southwest Research Institute electrical leak location system. Leak sizes and shapes ranged from relatively circular holes from less than 0.025 to 1 in. in diameter, to slits from 0.25 to 12 in. long, to gashes and gouges up to 6 by 8 in., to evidently tortuous paths through seam welds.

Figure 8  
Leak in HDPE Seam. Approximate Leak Size 0.025 In. (Note: Leak not apparent in reproduced photograph.)

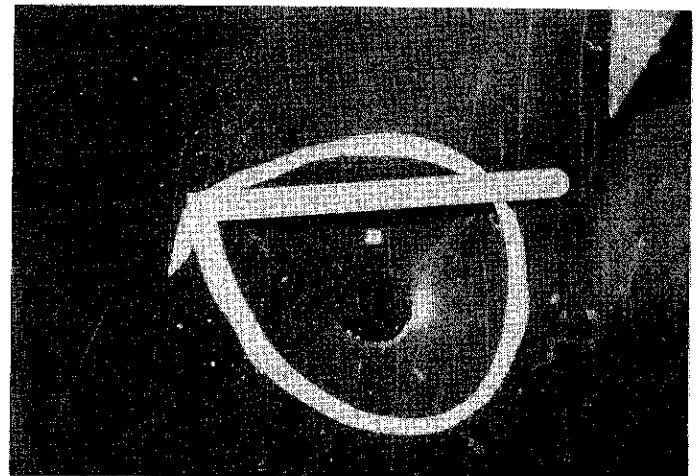
The leaks in the parent material generally can be attributed to accidental damage from equipment or tools, crescent-shaped cracks due to equipment being dropped, slits due to razor-edged tools cutting the liner, burns from cigarettes, gashes and gouges. Figures 10 and 11 show typical leaks in the parent material. Some of the leaks in the parent material probably were caused by improper material handling or wind buffeting. Many leaks in the parent material of installations with a protective soil cover appeared to have been created during the application of soil cover over the liner.

Figure 10  
Large Leak in HDPE Parent Material

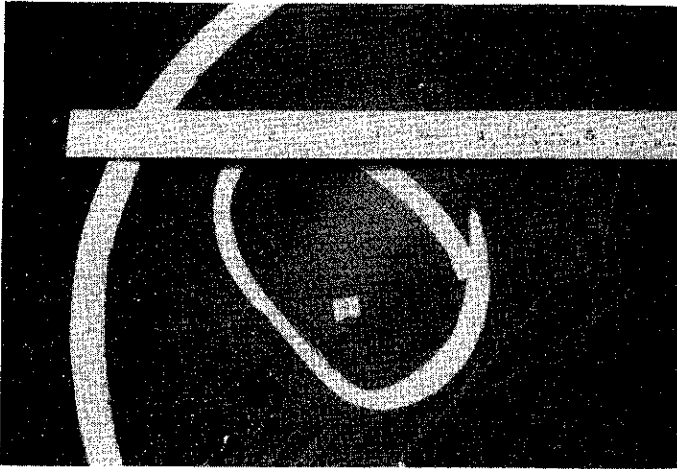
Figure 11  
Cut in HDPE Parent Material

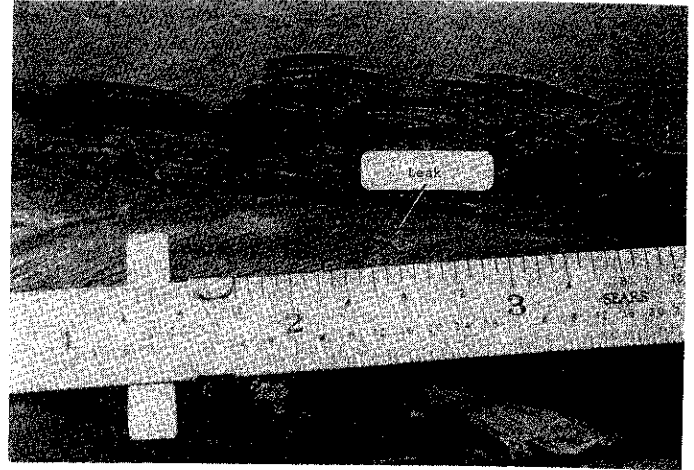
Figure 13  
Leak in Seam After Grinding, Just Prior to Repair

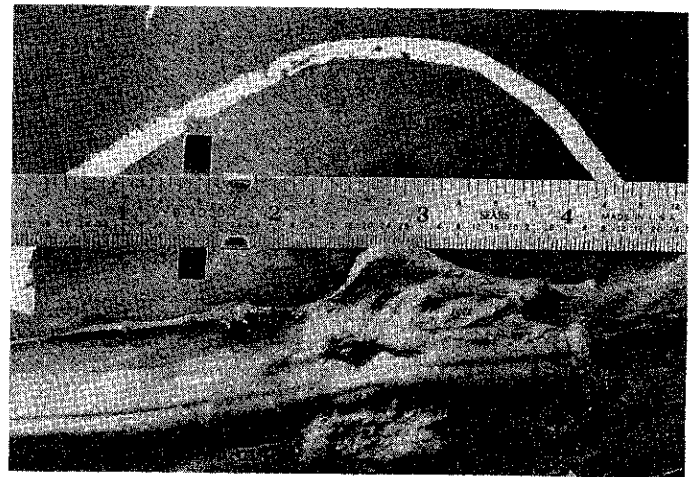
Inadequate field seaming appears to be the primary cause of leaks in geomembrane lined impoundments. Eighty-seven percent of the total number of leaks were in field welded or bonded seams. Many of the leaks occurred at T-joints, patches and at seams in highly-stressed areas such as at the base of the sideslope. Some leaks were found in seams which previously had been repaired and tested. Figures 12, 13 and 14 show typical leaks located in seams. Leaks may not develop in the seams until a hydrostatic load is placed upon the liner. Cases were documented where obviously poor seaming techniques resulted in seams failing indiscriminately after repair and hydrostatic loading. In such cases, it is suggested that the entire liner installation be redone.

Figure 14  
Leak in Seam Where Seaming Material Did Not Bond to Sheet

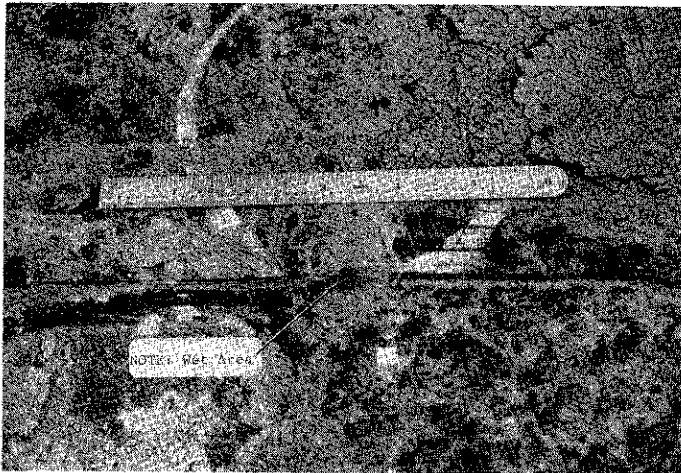
Figure 12  
Leak in Seam

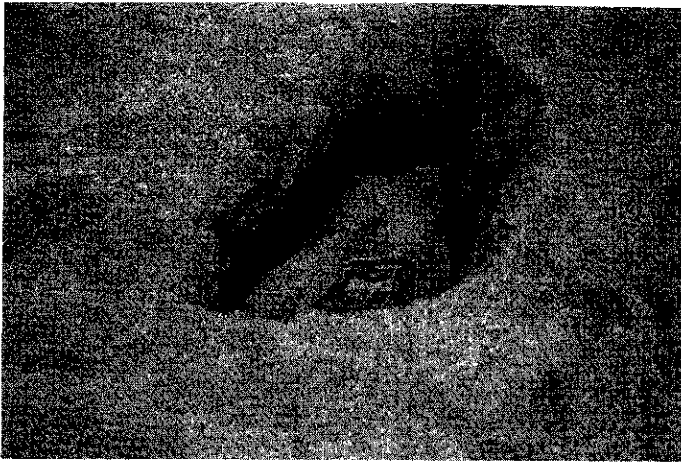
Figure 15  
Leak Under 2 ft of Protective Sand Cover

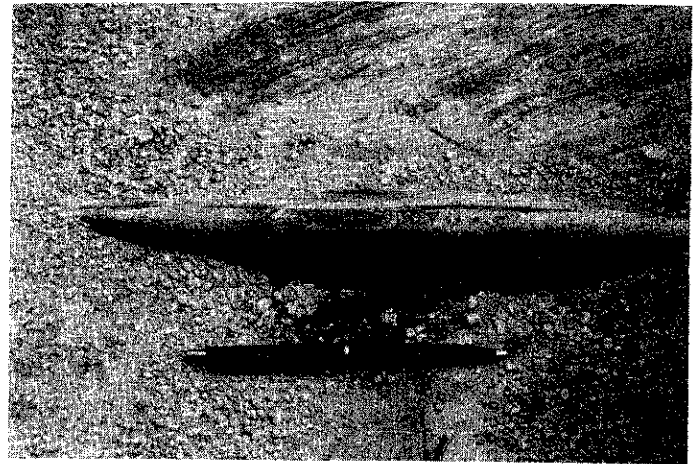
Figure 17  
Tear in Liner Covered with 2 ft of Sand

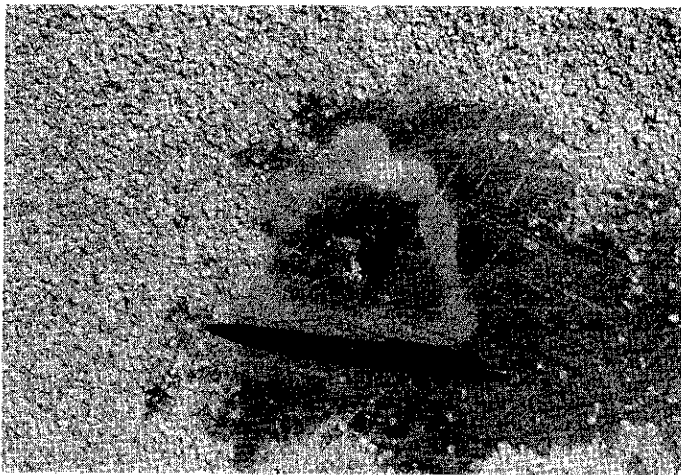
Figure 16  
Mechanical Damage to Liner Under 2 ft of Sand Cover
