**GEOSYNTHETICS : LESSONS
LEARNED FROM FAILURES**

Short Course Handout
Nashville, Tennessee, USA
20 February 1995

LESSONS LEARNED FROM GEOMEMBRANE LINER FAILURES LOCATED WITH THE HIGH-VOLTAGE ELECTRICAL LEAK LOCATION METHOD

by D. L. Laine and G. T. Darilek

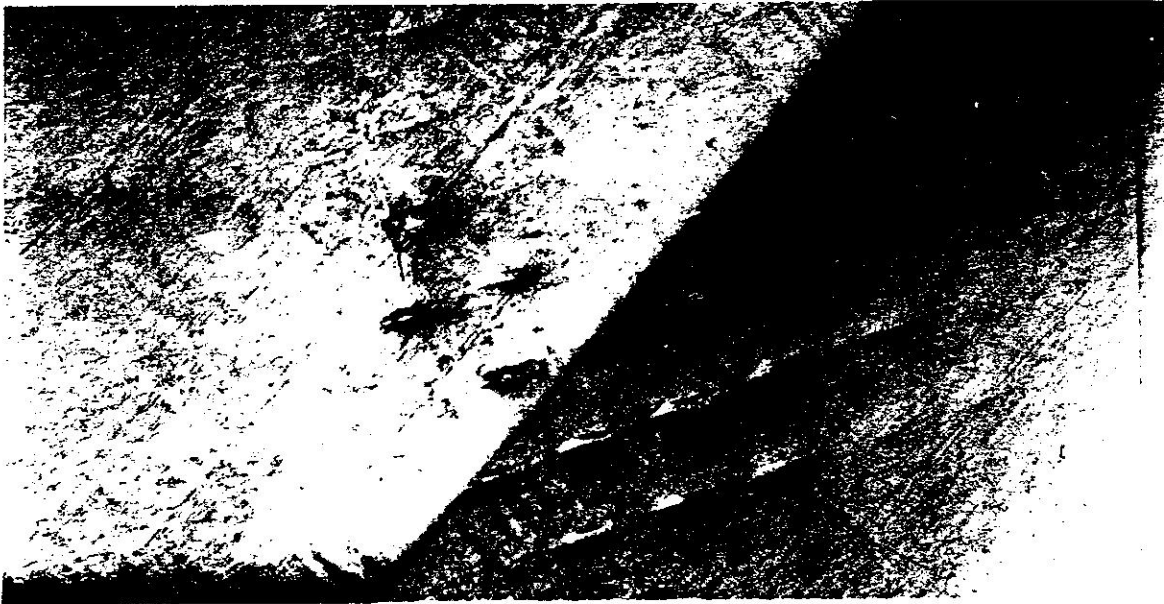
A very unusual liner failure was caused by the geonet drainage material punching a small hole in the primary liner. Figure 4 shows the backside of the primary 2 mm HDPE liner. The indentations and small hole were caused by the geonet pressing into the sheet. It is unknown how this failure occurred, but this may have been caused by a front-end-loader bucket pressing down on the soil covering the liner. The pressure of the bucket on the thin soil was so great that the geonet was extruded through the liner. This could have been prevented by using proper QC procedures.

Figure 4. Leak Caused by Geonet Cutting into the Liner Sheet

Many of the leaks caused by mechanical damage can be reduced by the proper use of written QC procedure. Razor cuts can be reduced by strict adherence to a QC plan that prohibits sharp pointed razors and other knives on the lined area and allows only hook type razor knives for cutting the liner sheet. Of course, the liner should never be used as a surface for cutting liner patches or other pieces of liner.
